BAJA SAE 2024

Technical Inspection Bulletin
#2

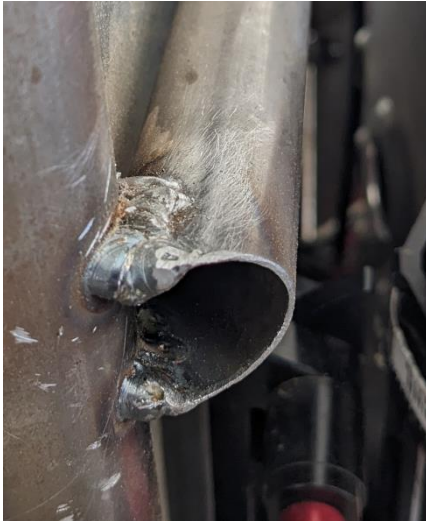
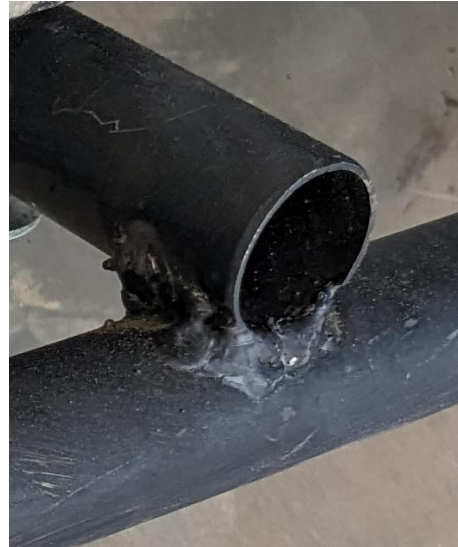
Tube Joints

- Tube joints must be fully welded.
- Incomplete fitment and incomplete welding is not acceptable.

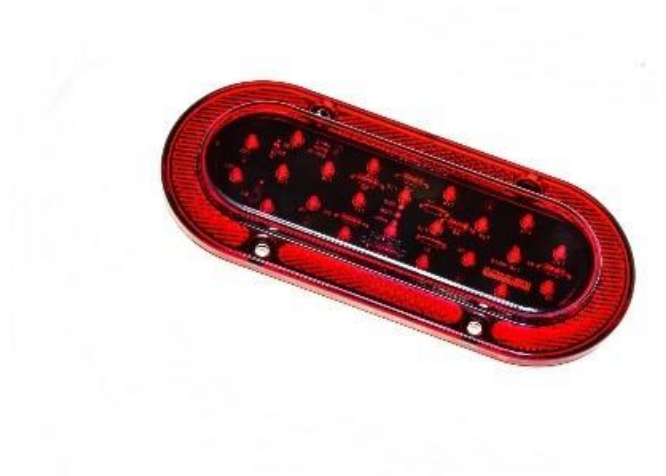
Brake Light

- **Improper wiring of Command Electronics 003-6016**
 - Teams using the Command Electronics brake light, model 003-6016 must take care to wire the brake light for stop mode only.
 - Many teams are using this brake light incorrectly wired in the tail mode. The tail mode is not bright enough. Teams must take extra care to wire the light properly.
