Tube Bending for Baja SAE

B.3.2 - Roll Cage Structure

The purpose of this document is to provide guidance on allowable defects in bent members

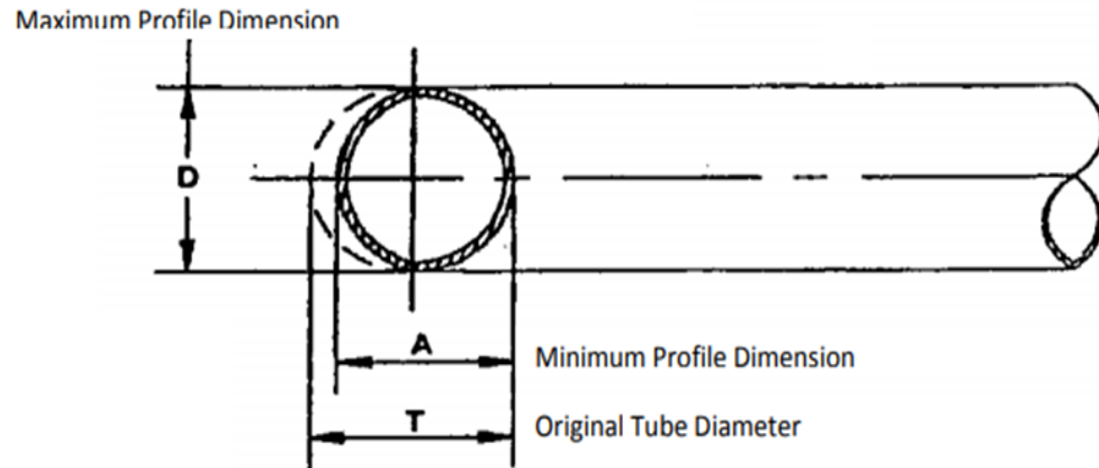
1. Ovality

When bending, the outside diameter tends to pull toward the centerline, causing the tube to flatten around the bend. Excessive flattening, or ovality, should not occur.

$$\frac{\phi_{MAX} - \phi_{MIN}}{Nominal \phi} \leq 10\%$$

Possible Solution: Use a larger bend radius. CLR should exceed 4x the tube OD.

Ovality, or flattening, of a bend should not exceed 10%

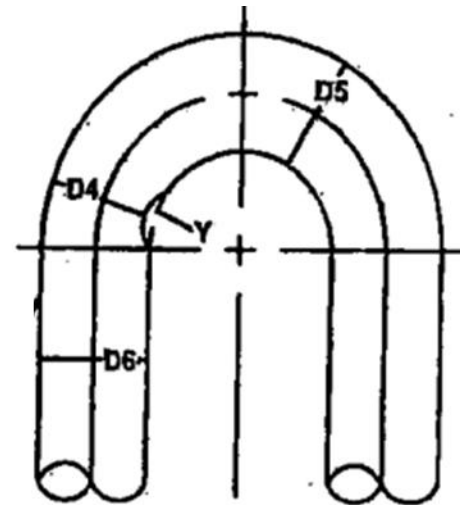
2. Kinks

If a tube buckles, or kinks, on the inside of the bend, the material is unable to support the compression loads during bending. This is typically an indication of poor support for the bend, die slippage or an inappropriately adjusted wiper die.

$D6 - D4 = \text{Depth of Kink}$

$$\frac{D6 - D4}{D5} \leq 15\% \text{ of Nominal OD}$$

- Adjust the pressure die closer to the tube or increase pressure on clamping device.
- The wiper die should be within 1/8 in. of the tangent, slightly raked away at the back.
- Check the tube wall thickness, variations occur, otherwise increase the thickness.

The depth of a kink should not exceed 15% of the nominal OD

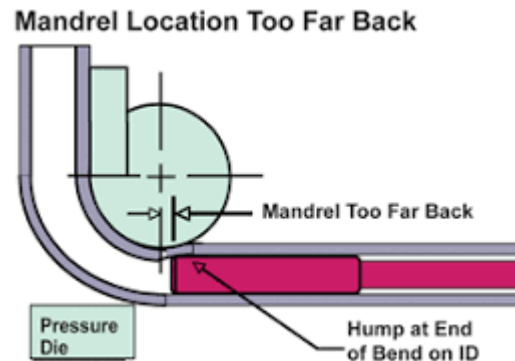
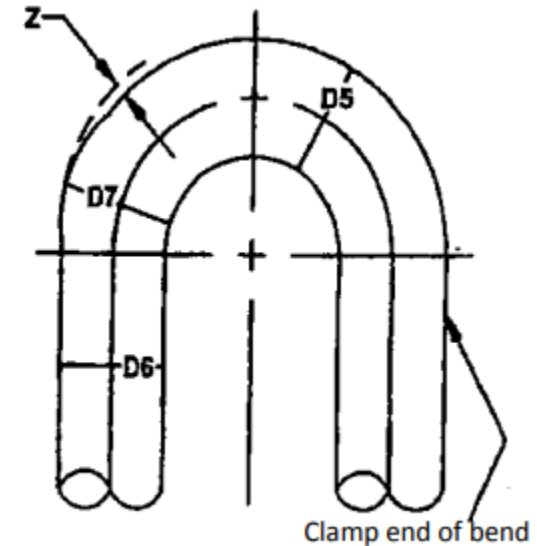
3. Humps

Tube humps, or outward bulging of the tube near the tangent of the bend, can occur on the inside or outside of the bend. This is typically the result of poor mandrel positioning.

$$D7 - D6 = \text{Height of Hump}$$

$$\frac{D7 - D6}{D5} \leq 10\% \text{ of Nominal OD}$$

- Bring the mandrel forward if the hump occurs on the inside of the bend. A straight portion of the mandrel should be at or just forward of the tangent.
- If the mandrel is too far forward, a hump will appear on the outside of the bend, near the end; move the mandrel farther back.

Hump height should not exceed 10% of the nominal OD

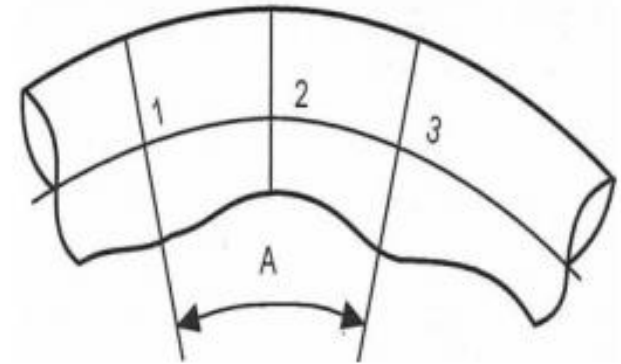
4. Wrinkles

Wrinkles are caused by high levels of compressive force on the inside of a pipe or tube with thin wall thickness, coupled with insufficient support of the bending dies.

Average Depth =

$$\frac{1 + 3}{2} \leq 3\% \text{ of Nominal OD}$$

Distance between wrinkles:

$$A \geq 12 * \text{Average Depth}$$

- Increase the clamping pressure in the dies.
- Reduce the clearance between the mandrel and the tube.
- Use less lubrication.

Wrinkling height should not exceed 3% of the nominal OD

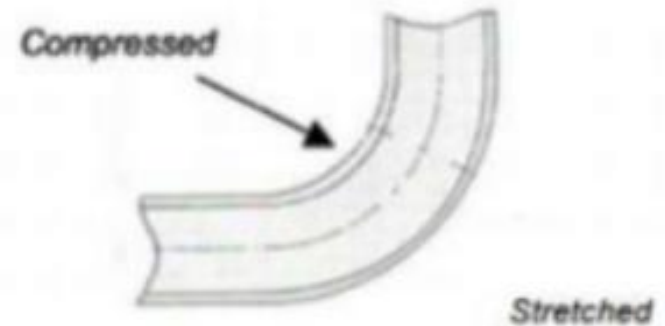
5. Thinning

Bending operations put the outside of the bend in tension and the inside in compression. As a result, the outside of a bend tends to thin. Wall thinning is directly related to bend centerline radius. Smaller radii produce higher stresses and more thinning.

C.L.R.	Tube OD	
	1.00	1.25
3	14%	18%
5	9%	11%
8	6%	7%

CLR < 4 results in excessive thinning
